INSTALLATION STATUS REPORT (ISR)

RESEARCH & DEVELOPMENT BUILDINGS

STANDARDS BOOKLET

BOOKLET 11

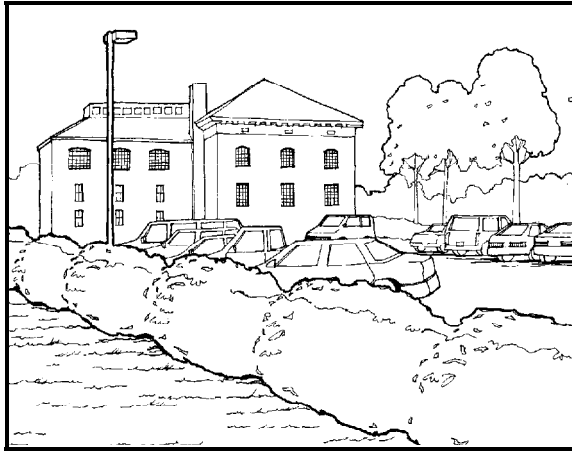
GREEN

- Smooth, level pavement without large holes or cracks
- Parking spaces marked and adequately sized
- Drainage adequate
- Parking close to facility
- Handicapped parking provided
- High efficiency site lighting
- Adequate parking for all employees and visitors
- Site fully developed with landscaping and site features

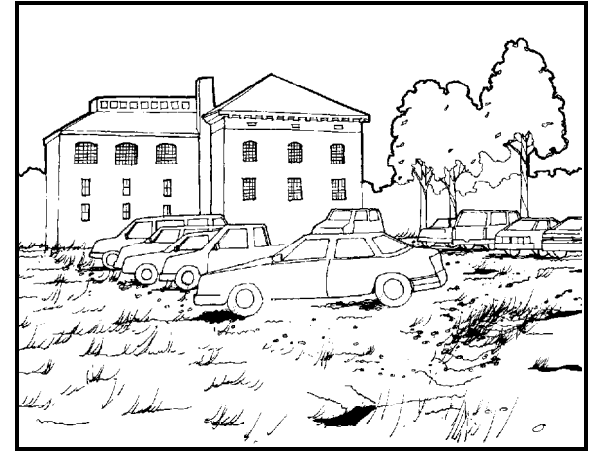
RED

- Unpaved
- Parking spaces not identified
- Drainage problems
- No parking within the vicinity of the facility
- No handicapped parking provided
- No site lighting
- Inadequate parking for employees and visitors
- Open lot without distinguishing features

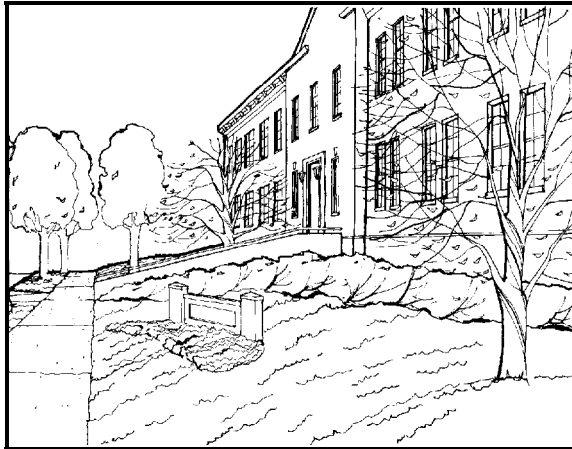
GREEN

- Exterior components, colors and materials have a coordinated design theme; walls, windows and doors in sound condition
- Roof in good repair and fits architectural theme
- Gutters & down spouts function and fit design theme
- Entry emphasized by design
- Full handicapped access integral part of design
- Mechanical equipment screened in keeping with building design
- Exterior signage clearly visible and readable

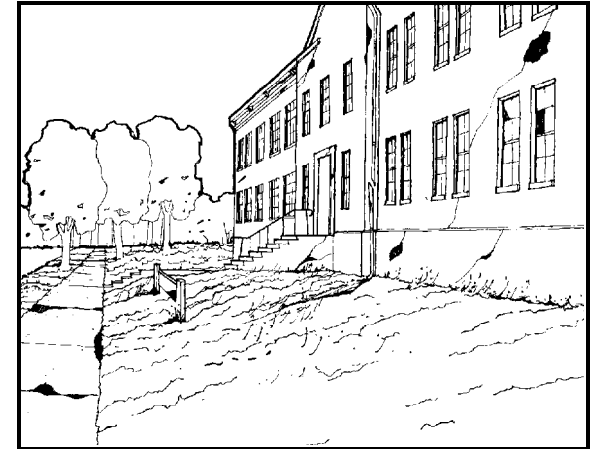
RED

- Exterior walls have cracks and need painting, windows, doors, & siding broken or missing
- Roof leaks
- Gutter and down spouts missing or broken
- Entry in disrepair
- Building inaccessible to handicapped
- Unscreened mechanical equipment
- Inadequate exterior signage
